**HANKINS POND DAM**

NDI NO. PA-00169

**PHASE I INSPECTION REPORT  
NATIONAL DAM INSPECTION PROGRAM**

Name of Dam: HANKINS POND, NDI NO. PA-00169  
State & State No.: PENNSYLVANIA, 64-40  
County: WAYNE  
Stream: TRIBUTARY TO WEST BRANCH LACKAWAXEN RIVER  
Date of Inspection: October 24, 1979

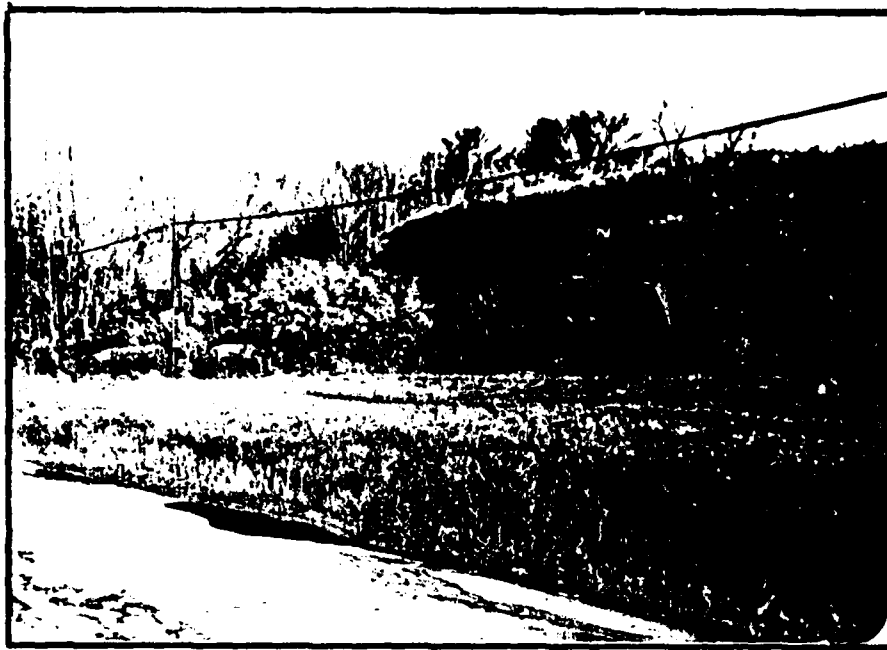
The crest of the dam is covered with grass and is, in general, slightly higher than the stone wall on the downstream side. The longitudinal profile was taken along the crest of the earth embankment, rather than along the top of the wall. The sluiceway (spillway) is located in the right half of the embankment length and is covered with wooden boards and a concrete slab. The downstream section of the dam is formed by loose handlaid stone. The outside face is nearly vertical and there were no signs of stress or failures along this wall. One large stone on the top has a date of 1869, although records indicate that the dam was constructed around 1830. A catch-basin has been constructed at the outlet of the sluiceway. Representatives of the owner stated that when the pool is at normal level, water seeps through the wall near the bottom at three places in this basin. No other seepage points were reported and no signs of seepage were found along the wall, except near the right end of the wall. This point appears to be higher than the pool level at the time of inspection, and the wet condition could therefore

The downstream masonry wall of this 150 year old dam is in excellent condition. No distortions are noticable and no movements have taken place. It was reported that some seepage or leakage is occurring at the toe of the wall in the catch-basin when the reservoir is full. There are no reasons for concern if the discharge is small and has no turbidity.

DOWNSTREAM DRY STONE WALL - NO. 4

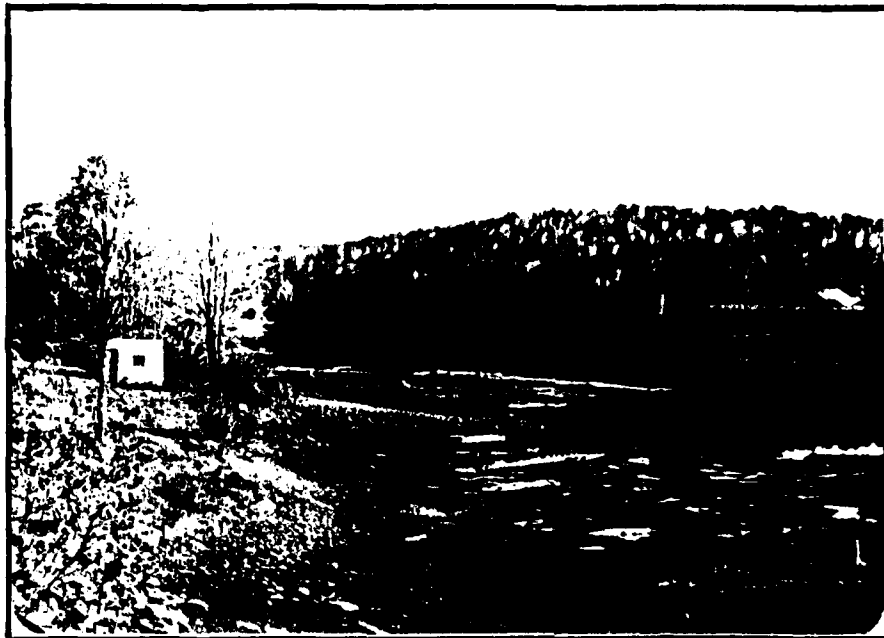
As previously described, this earthfill embankment has a handlaid vertical dry stone wall on the downstream side. The embankment was constructed on a long horizontal curve across the valley. The upstream slope was exposed due to the drawdown of the reservoir. The slope appeared to be stable. Brush is present above the normal pool level and four trees are located on the slope near the right end of the embankment. The only evidence of slope protection is around the entrance to the sluiceway. The riprap did not show any failures and there were no signs that wave action had damaged other areas of the upstream slope. One woodchuck hole exists near the spillway. Heavy brush prevented close observation.

RESERVOIR IN DRAWDOWN CONDITION - NO. 3
